# Market surveillance on Compressors

Catherine Hardy  
HSE Safety Unit

# Compressors market surveillance

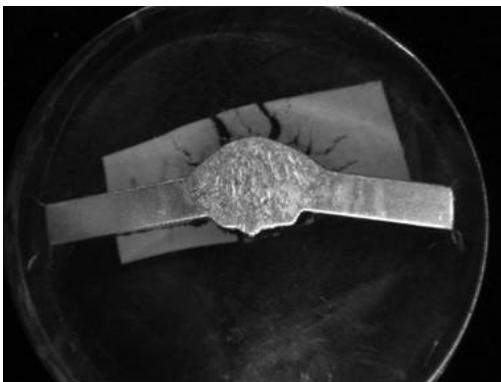
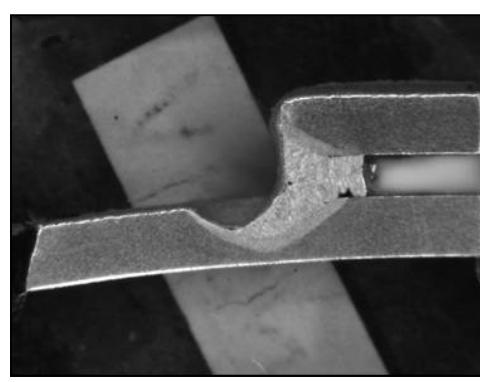
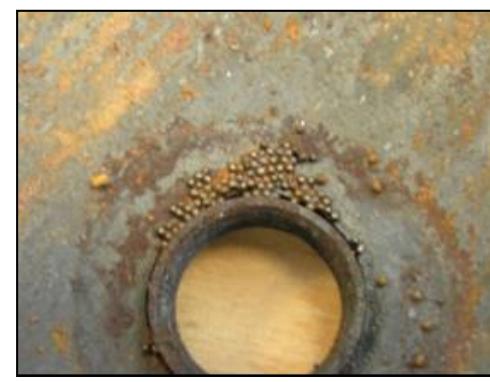
- Poor quality welding, eg porosity, slag inclusions, peaking undercut
- Lack of data on ID plate
- No certificate of conformity
- Operation of drain valve and inspection ports
- Shot blasting beads had been left inside one of the vessels
- In another vessel, the drain hole was not at the lowest point of the vessel

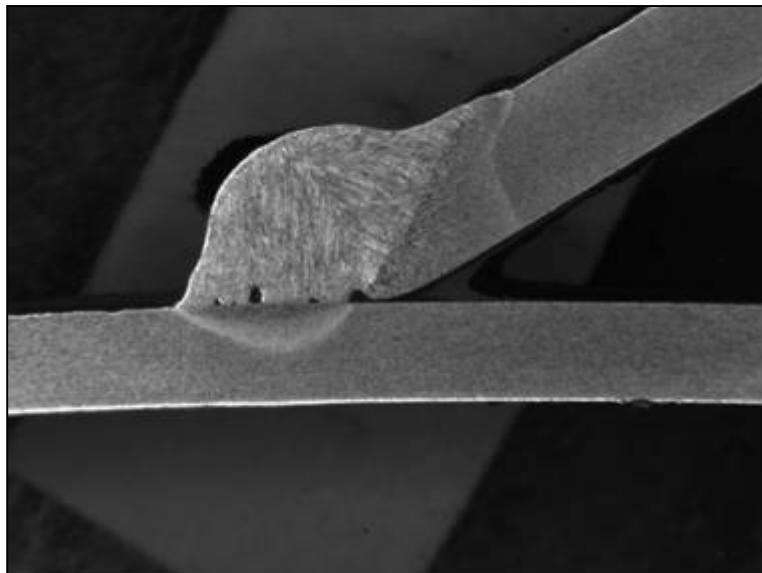
Lack of fusion

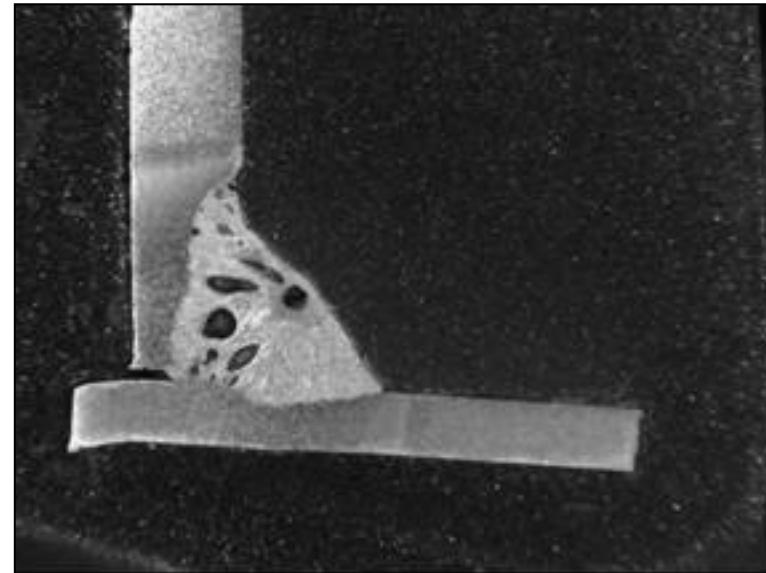
Porosity in weld

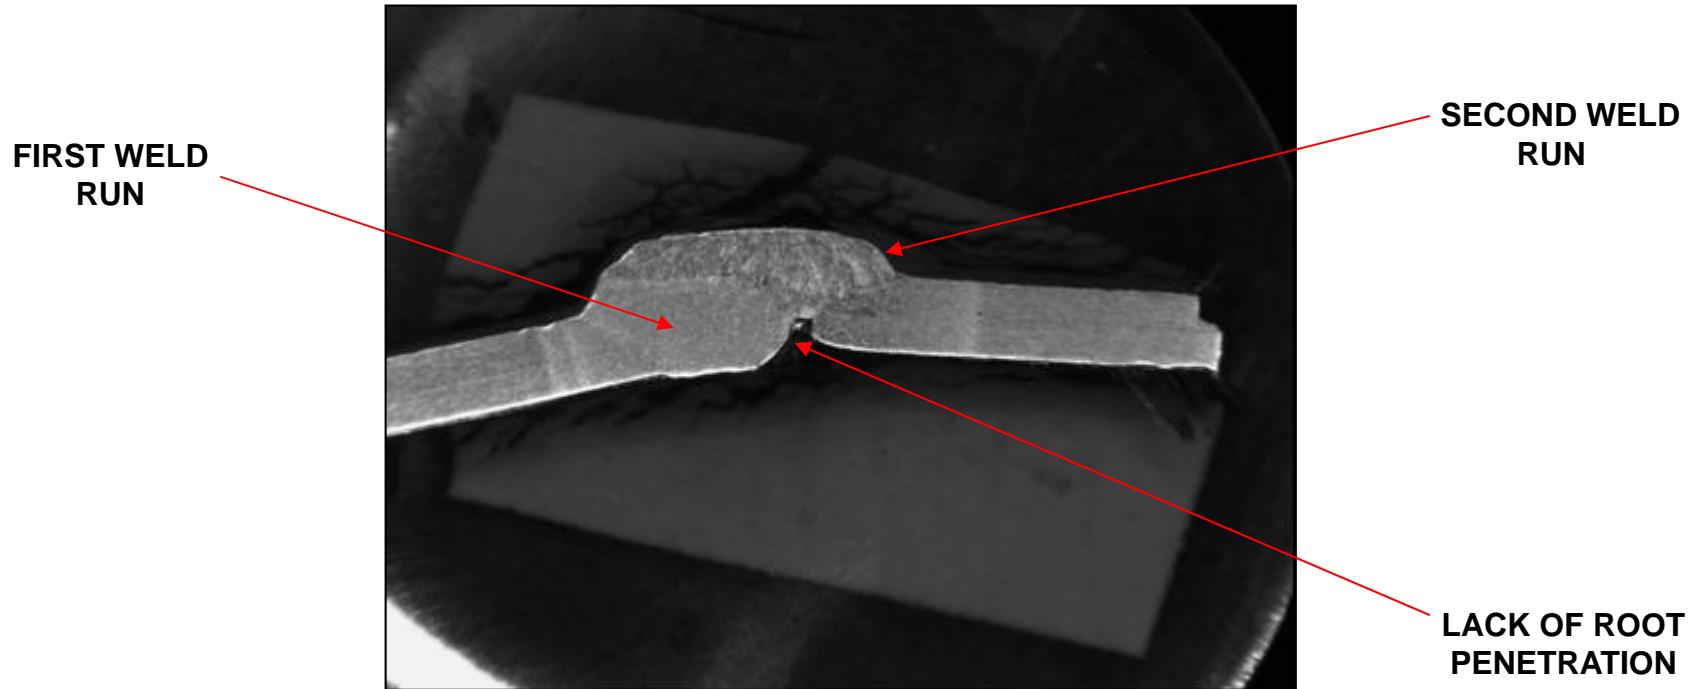
Longitudinal seam weld – lack of fusion and root penetration  
(2 weld runs – one missed the other not penetrated fully)  
Joint also Peaked

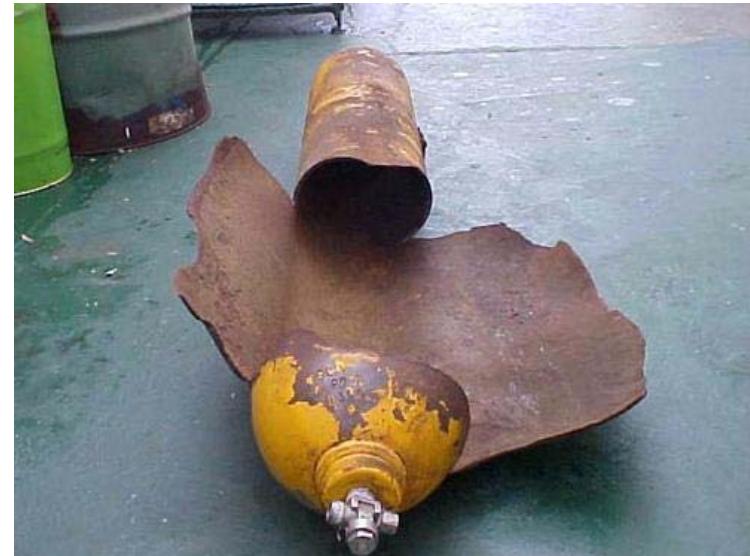
- More likely to leak than burst
- Relatively small capacities
- Failure along the length of the vessel would be either:
  - progressive deterioration along the weld
  - catastrophic explosion from overpressure or internal reduction in wall thickness (corrosion)

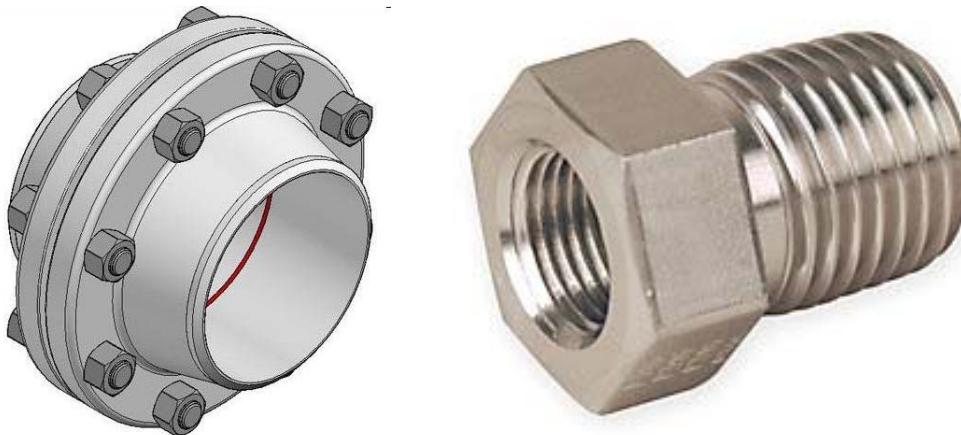
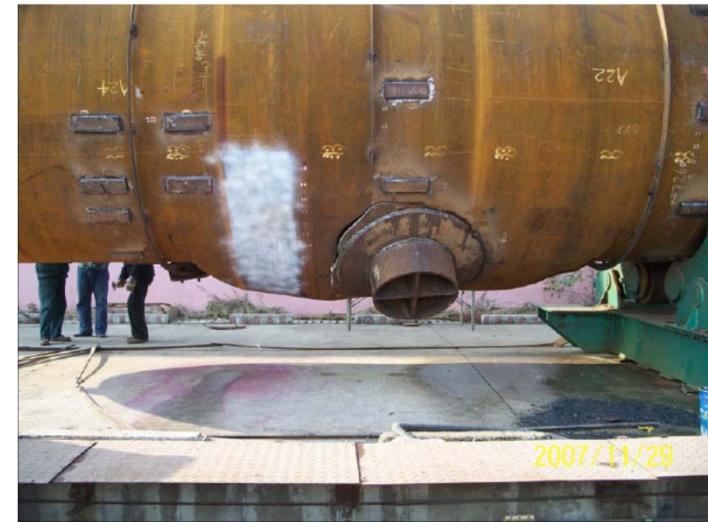
- Greater potential for significant release from jointed connections or dome ends
- Rapid change in sectional area
- Failure initiation results in offset loading
